WHEELER POND DAM CT 00239

PHASE 1 INSPECTION REPORT NATIONAL DAM INSPECTION PROGRAM

84 07 25 169
SEPTEMBER 1978

THAMES RIVER BASIN
MONTVILLE, CONNECTICUT

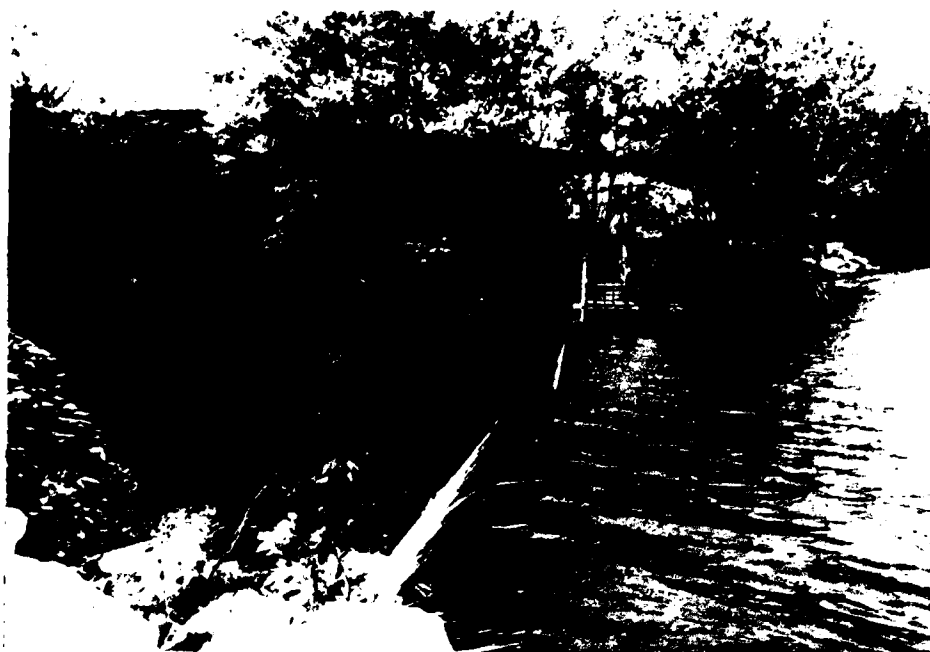
C-2 SPILLWAY CREST-LOOKING TOWARD RIGHT ABUTMENT
(NOTE: CLOSE PROXIMITY OF MILL BUILDING.)

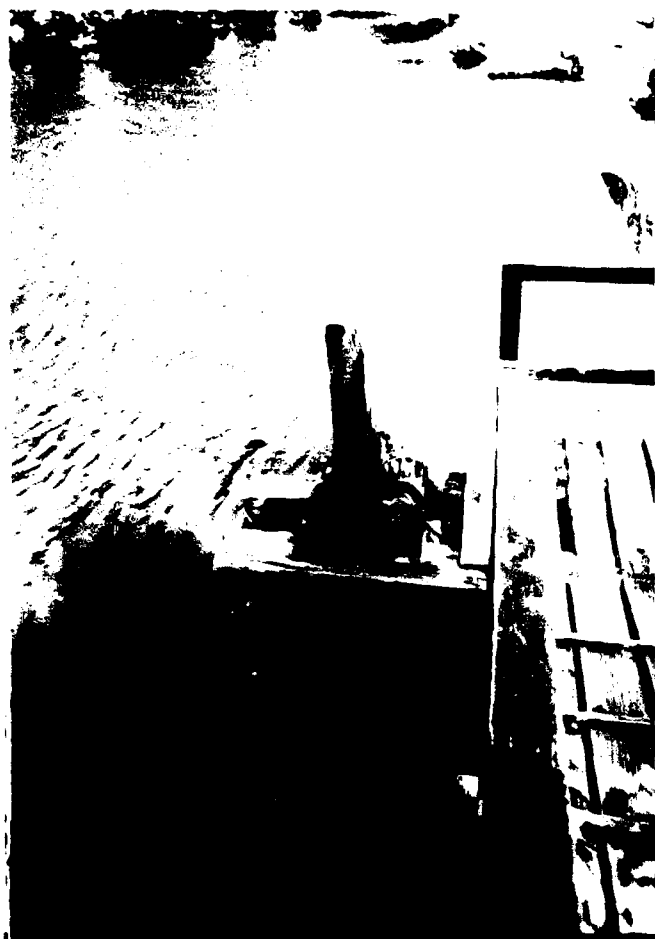
The low level sluice gate (outlet works) in the vertical masonry section of the dam was closed and inoperable. The access bridge to the gate control was badly weathered and in disrepair. The right abutment training wall has settled with stones dislodged and loosened.

C-4 OPERATING MECHANISM
FOR LOW LEVEL SPILLWAY
GATE OUTLET.

- b. Drawdown the water level in order that the low level gate at the spillway can be repaired or replaced which will increase the outlet capacity for emergency and repair situations.

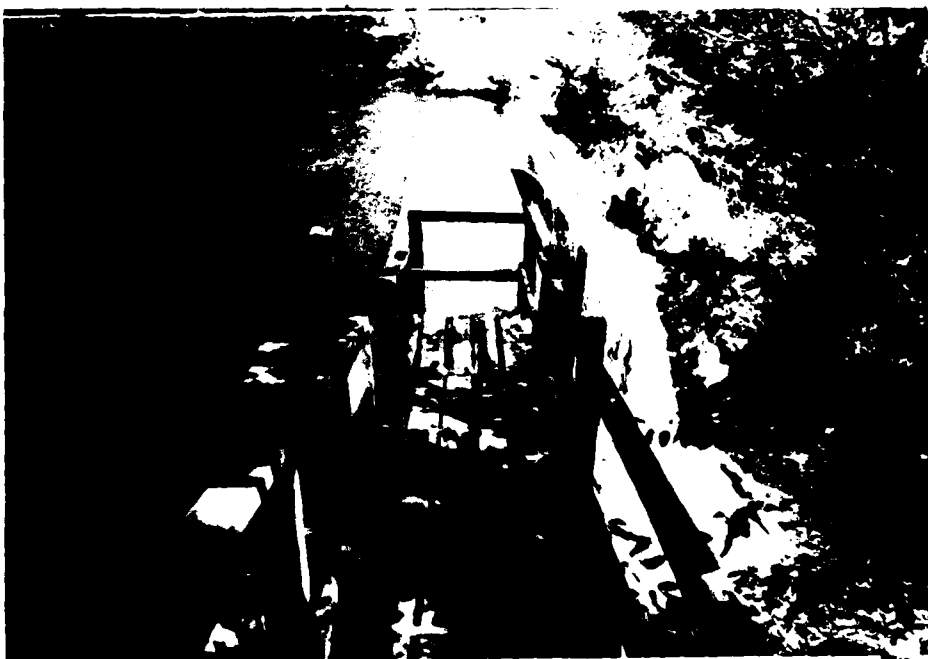
| AREA EVALUATED | CONDITION |
|---|--|
| <p><u>OUTLET WORKS - SERVICE BRIDGE</u></p> <p>a. Super Structure Bearing Anchor Bolts Bridge Seat Longitudinal Members Under Side of Deck Secondary Bracing Deck Drainage System Railings Expansion Joints Paint</p> <p>b. Abutment & Piers General Condition of Concrete Alignment of Abutment Approach to Bridge Condition of Seat & Backwall</p> | <p>Wood access bridge in poor condition. Exposed to severe ice damage heave, etc.</p> <p>None</p> |

C-5 SERVICE BRIDGE LEADING TO OUTLET CONTROL

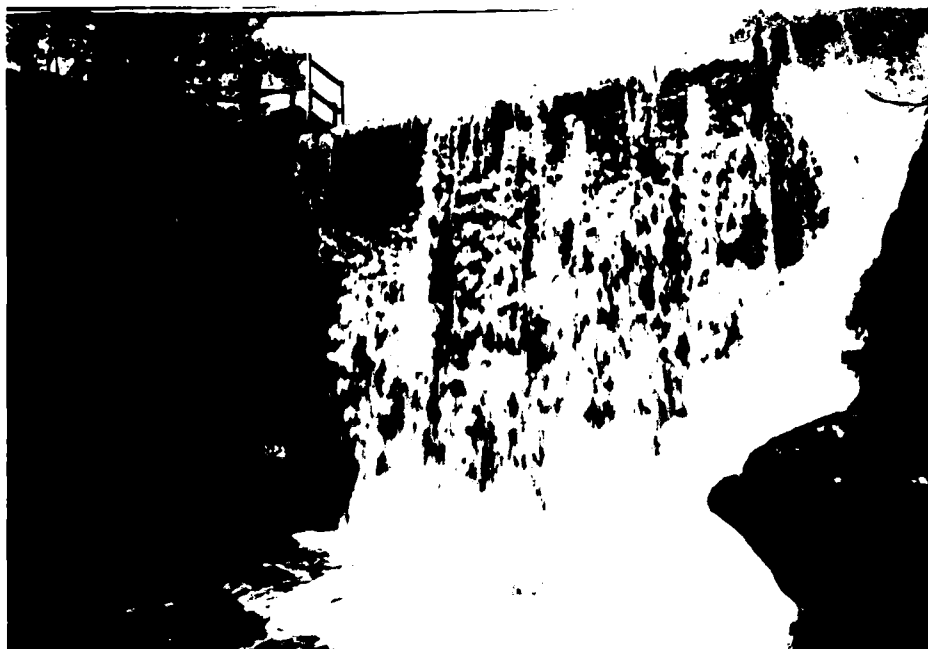
C-6 DOWNSTREAM FACE OF DAM. (NOTE: DARK AREA BELOW SERVICE BRIDGE - OUTLET GATE OPENING.)

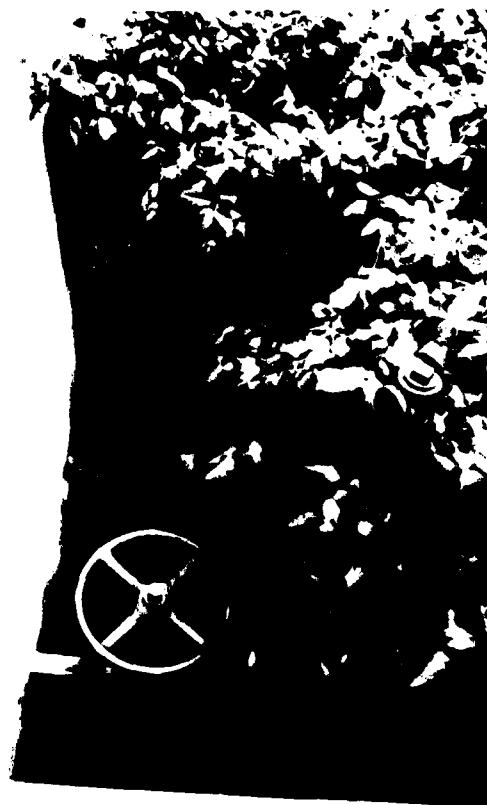
C-9 VALVE PIT - FOR PROCESS
WATER SUPPLY TO MILL AND
BY - PASS
